A DATA-DRIVEN CONDITION ASSESSMENT

**FOR ASPHALT REJUVENATION USING
MALTENE REPLACEMENT
TECHNOLOGY**

**SEPTEMBER 2021
PREPARED BY JAMES GOLDEN**

PMG
PAVEMENT MANAGEMENT GROUP

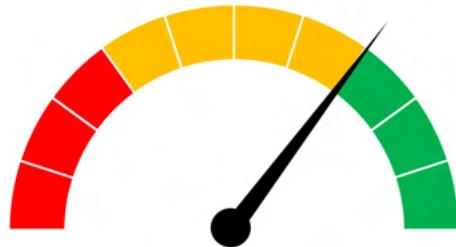
70 PCI

Distress	Description	Severity	Quantity	Units	Density	Deduct	
10	L & TCR	Low	300.00	ft		15.00	20.72
19	RAVELING	Medium	200.00	SqFt		10.00	18.48
20	WEATHERING	Low	2,000.00	SqFt		100.00	5.18

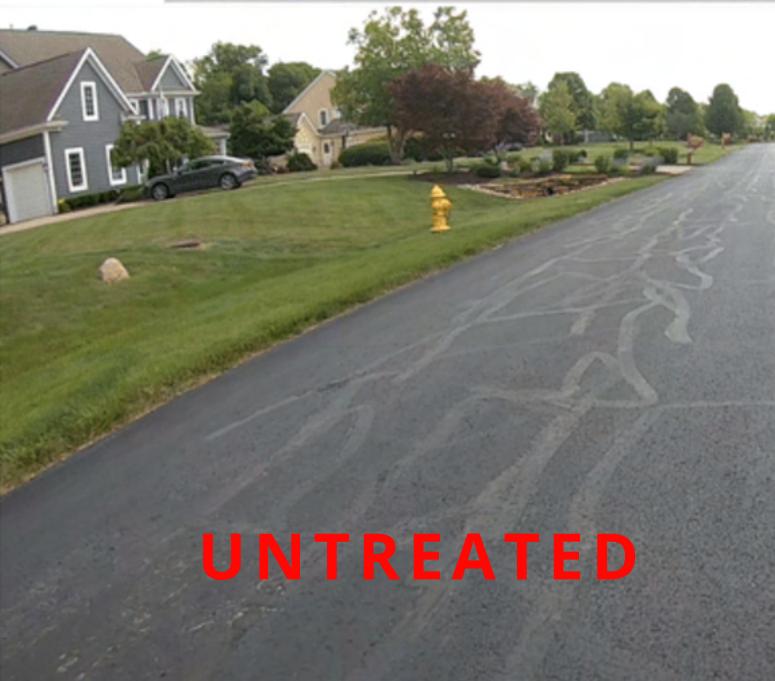
UNTREATED

The untreated lane shows noticeable longitudinal and transverse cracking that has been treated with a crack seal since being paved in 2013. Furthermore, you can see signs of raveling throughout 10% of the surface, and weathering throughout 100% of the surface.

After documenting these distresses within the PAVER® pavement management system, the PCI of the untreated lane is a 70.

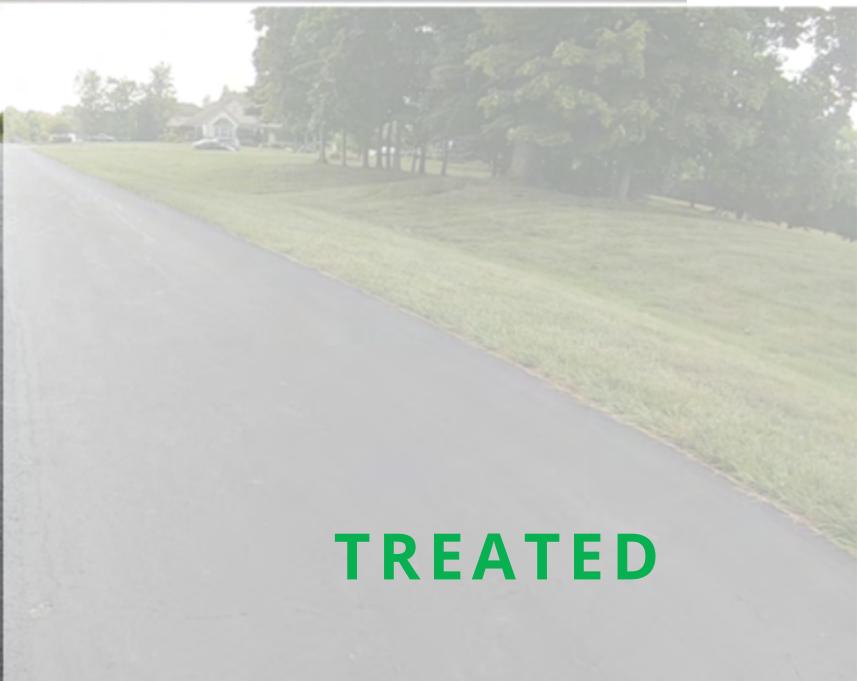
TREATED

The treated lane shows that while longitudinal and transverse cracking is visible, it has just started to form and take shape. Furthermore, there are no signs of raveling within the treated surface, with light severity weathering only present within 20% of the surface.

After documenting these distresses within the PAVER® pavement management system, the PCI of the treated lane is 84.

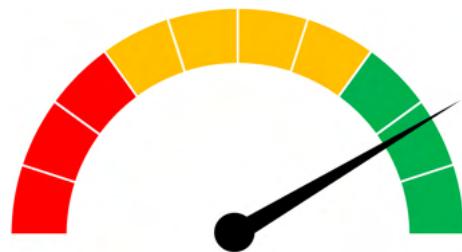
84 PCI

Distress	Description	Severity	Quantity	Units	Density	Deduct
10	L&TCR	Low	150.00	ft	7.50	13.90
20	WEATHERING	Low	400.00	SqFt	20.00	2.46

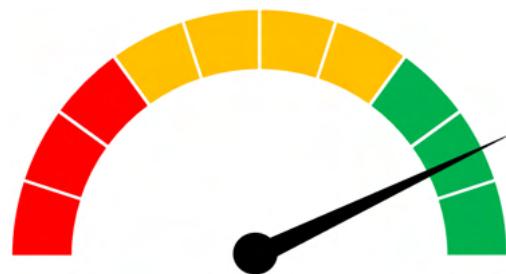
85 PCI

Distress	Description	Severity	Quantity	Units	Density	Deduct
10	L & TCR	Low	60.00	ft	2.50	5.91
10	L & TCR	Medium	35.00	ft	1.46	11.18
20	WEATHERING	Low	2,400.00	SqFt	100.00	5.18

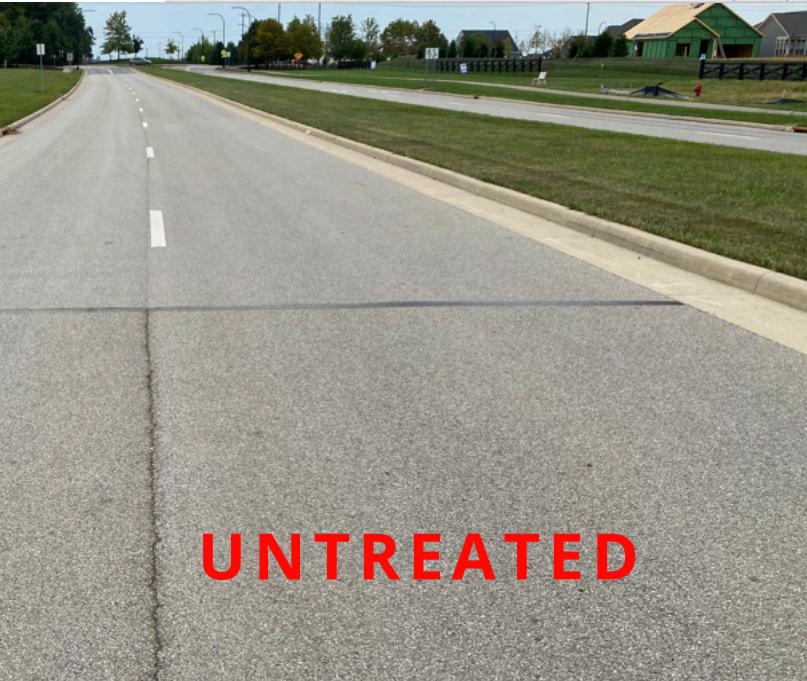
The untreated segment shows noticeable light and medium severity longitudinal cracking along the paving joint with light severity weathering present throughout 100% of the surface.

After documenting these distresses within the PAVER® pavement management system, the PCI of the untreated segment is 85.

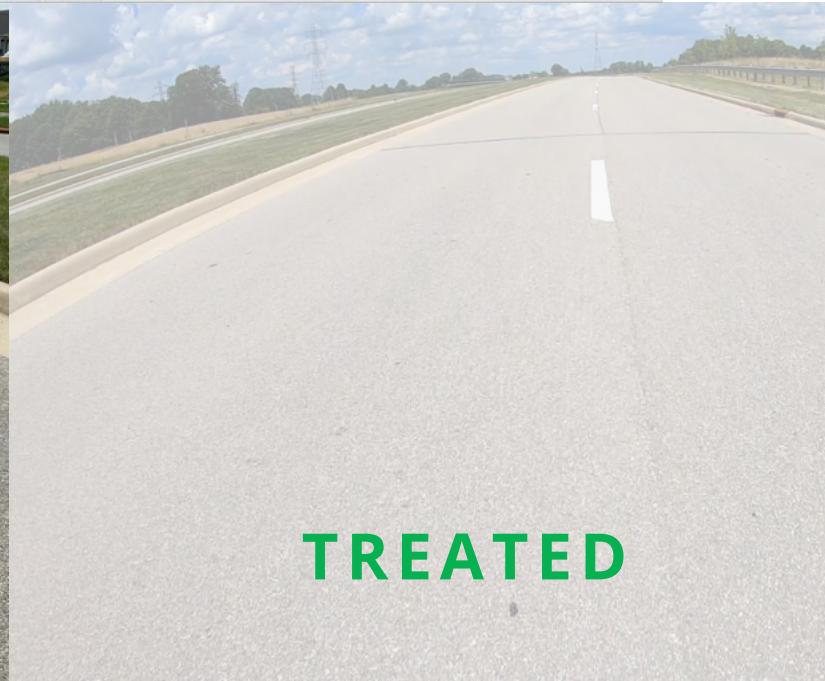
The treated segment shows minimal, light severity longitudinal cracking along the paving joint, with light severity weathering present throughout just 50% of the surface.

After documenting these distresses within the PAVER® pavement management system, the PCI of the treated segment is 95.
