A DATA-DRIVEN CONDITION ASSESSMENT

**FOR ASPHALT REJUVENATION USING
MALTENE REPLACEMENT
TECHNOLOGY**

**SEPTEMBER 2021
PREPARED BY JAMES GOLDEN**

PMG
PAVEMENT MANAGEMENT GROUP

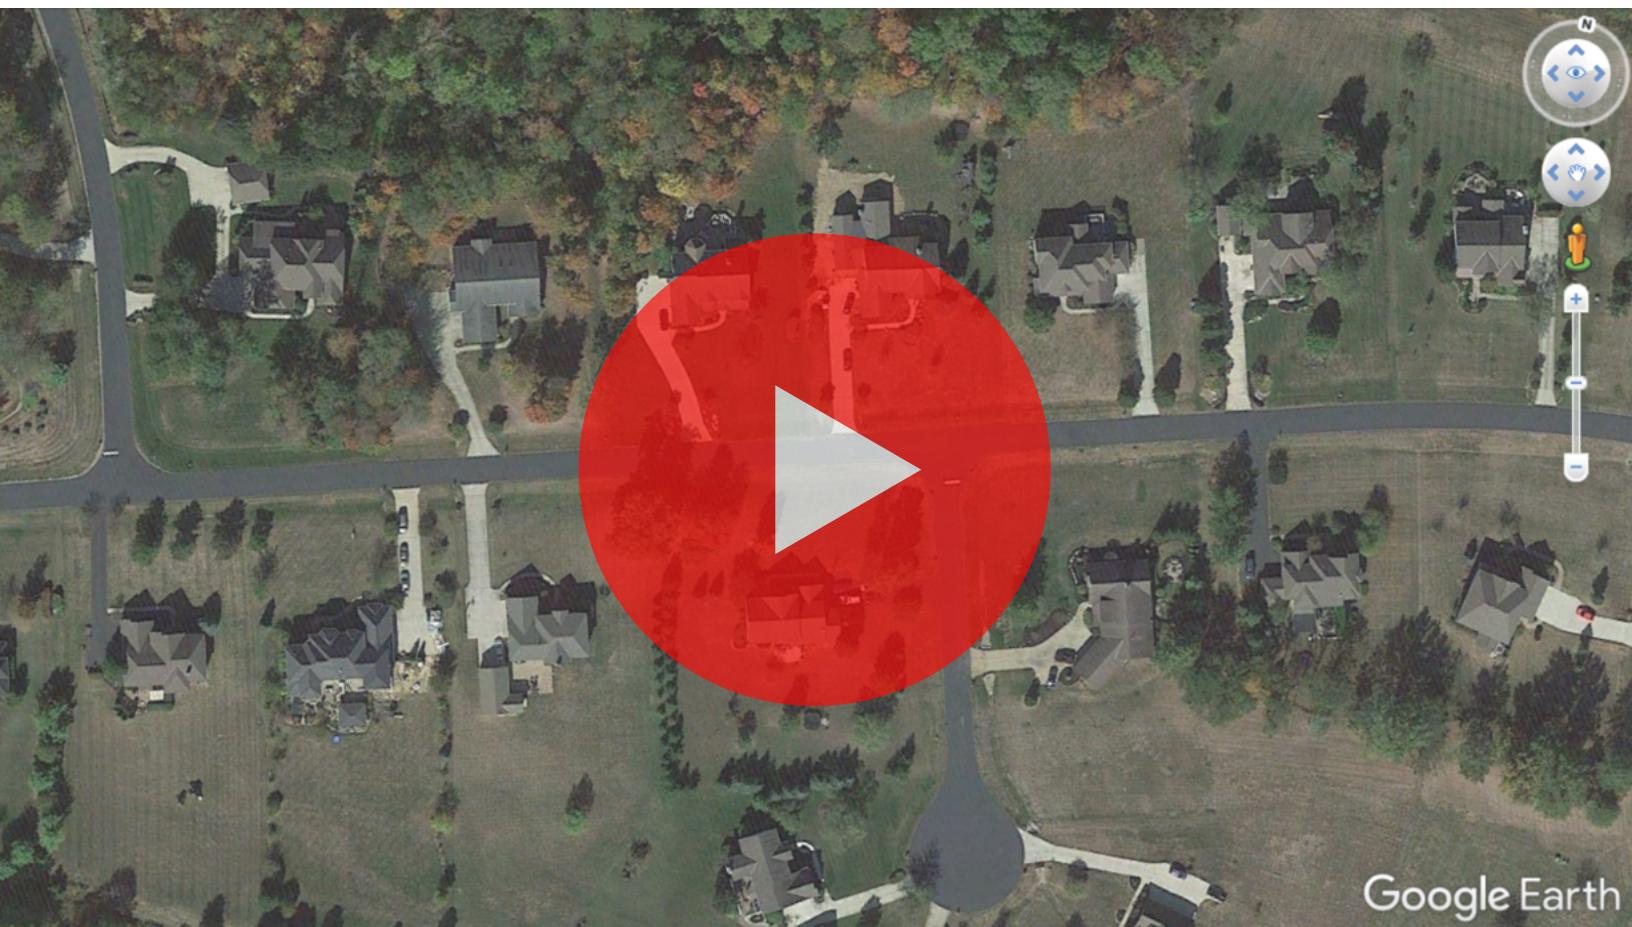
STREAMSIDE DRIVE, UNTREATED

The untreated lane shows noticeable longitudinal and transverse cracking that has been treated with a crack seal since being paved in 2013. Furthermore, you can see signs of raveling throughout 10% of the surface, and weathering throughout 100% of the surface.

After documenting these distresses within the PAVER® pavement management system, the PCI of the untreated lane is a 70.

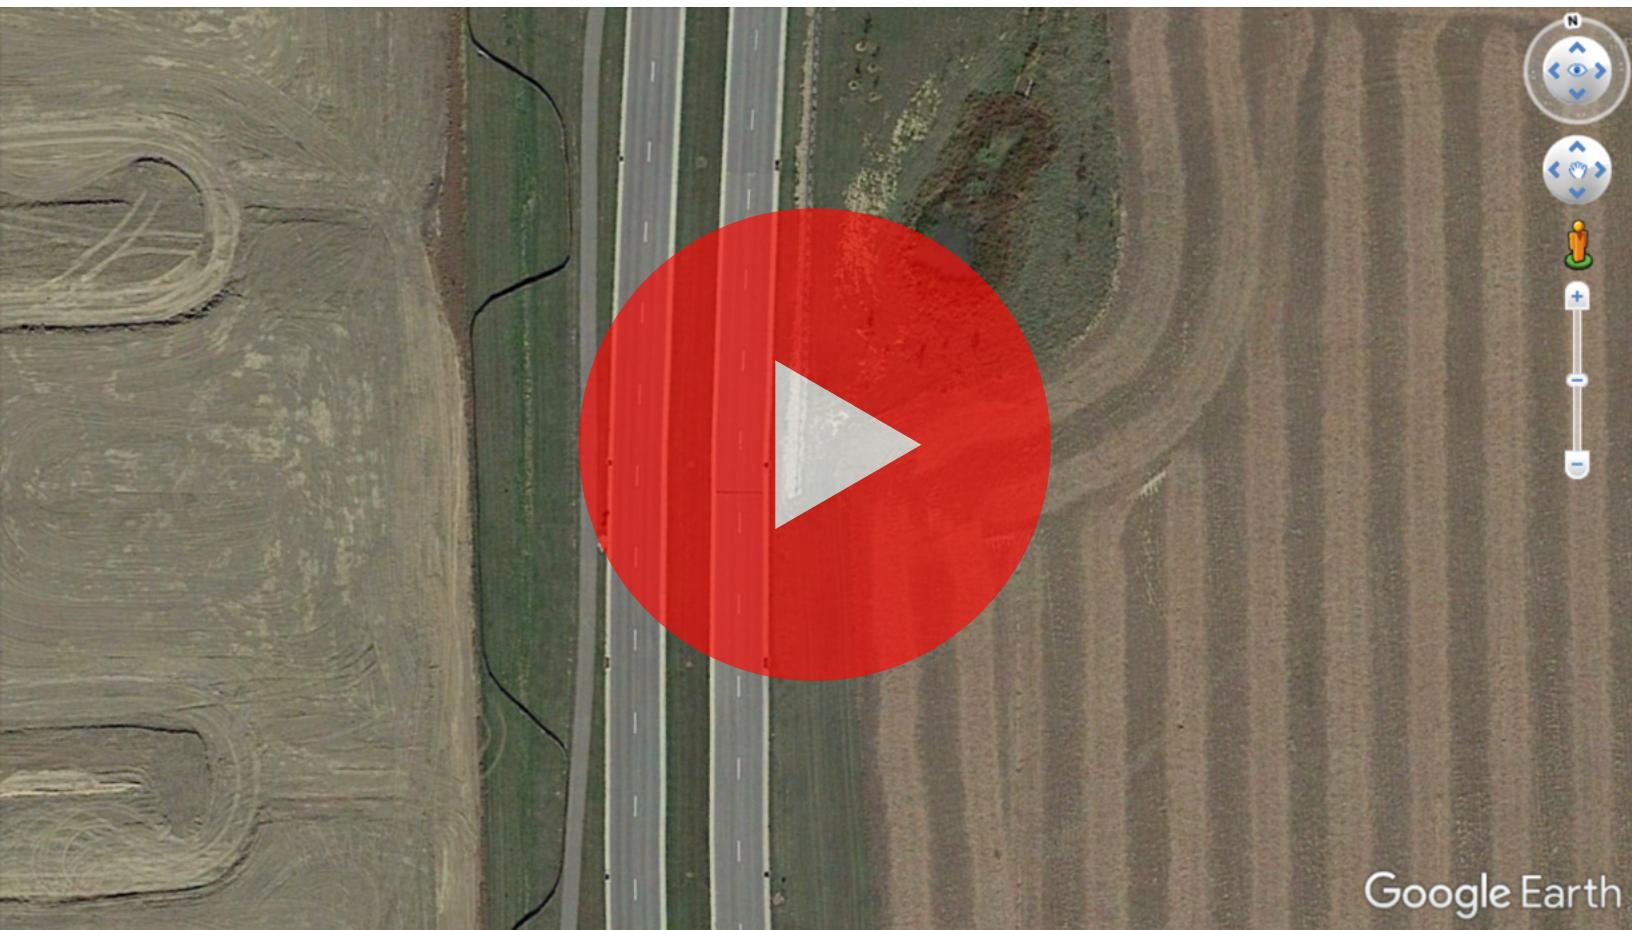
SAWMILL PARKWAY, UNTREATED

The untreated segment shows noticeable light and medium severity longitudinal cracking along the paving joint with light severity weathering present throughout 100% of the surface.

After documenting these distresses within the PAVER® pavement management system, the PCI of the untreated segment is 85.

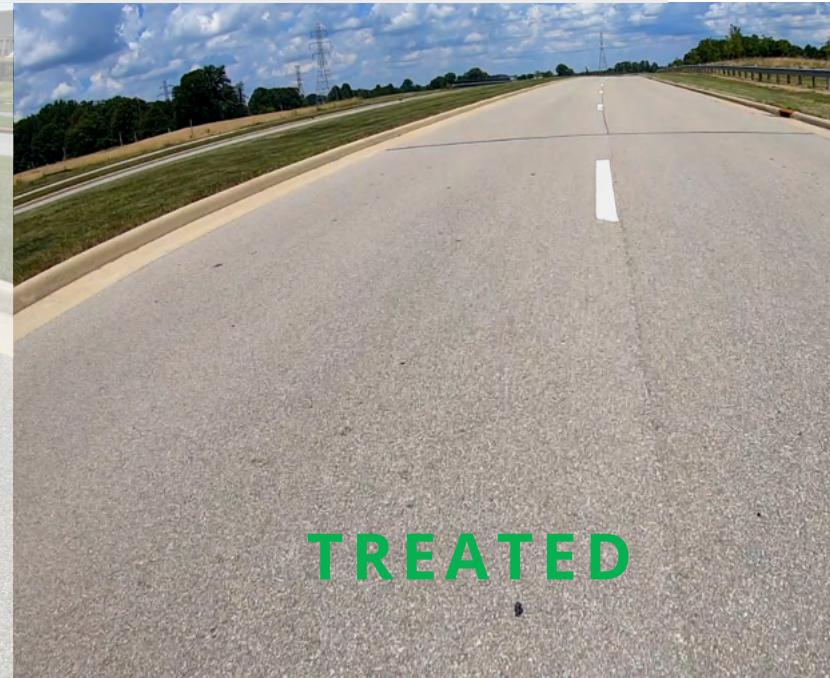
The results of this study clearly show the value of applying an MRT application such as Reclamite® within the first three (3) years of an asphalt installation. This preservation practice seals the pavement surface to shed water and prevent intrusion. It also penetrates to delay the inevitable climate-based cracking that occurs early on within a pavement's life cycle.

Based upon the age of each pavement and PCI calculated from the ASTM D6433 condition assessment, the untreated locations lost an average of 3.5 PCI points per year, while the treated locations lost an average of just 1.5 points per year; resulting in a 2 point PCI gain.
